**Flood Control Project Maintenance
Levee Inspections**

Maintenance Issue Types Only, Levee Inspection Report By Mile - Fall 2019

Sutter Maintenance Yard East-West Interceptor

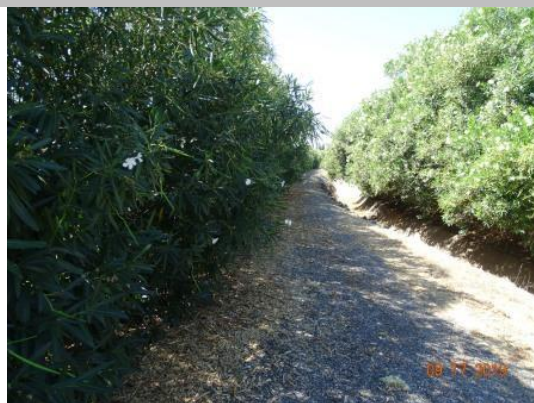
Photo 1 of 1 : FA_2019_ST0020_213_25_20190918_00026.jpg

LM Start	0.51	Rating **	U	Issue No.	25
LM End	0.67	Issue Type +	Ma	Location *	LS
Category	Earthen Levee			GPS Latitude/Longitude	
				Start	End
Item	Trim / Thin Trees			39.171392 °	39.171345 °
				-121.750478 °	-121.747585 °
DWR ID	DWR_ST0020_01_f_2016_25				
Comment Code					
T3 : Trim and thin trees to allow visibility of the ground and room to flood fight.					
Inspector Comment					
Olleanders are significantly blocking visibility and access.

View of the olleanders that are significantly blocking vehicle access. Fall 2019.

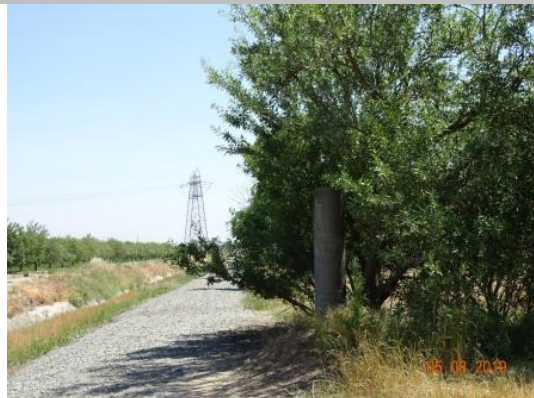
Photo 1 of 1 : FA_2019_ST0020_213_15_20190822_00003.jpg

LM Start	1.10	Rating **	M	Issue No.	15
LM End	1.10	Issue Type +	Ma	Location *	LS
Category	Earthen Levee			GPS Latitude/Longitude	
				Start	End
Item	Trim / Thin Trees			39.171290 °	39.171290 °
				-121.739639 °	-121.739639 °
DWR ID	DWR_ST0020_01_s_2019_15				
Comment Code					
T1 : Trim trees to at least five feet above ground level.					
Inspector Comment

View of the trees on the landside slope. Spring 2019.

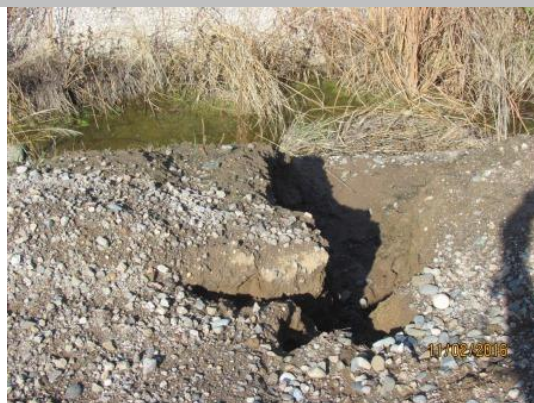
Photo 1 of 1 : FA_2019_ST0020_213_22_20190822_00009.jpg

LM Start	1.33	Rating **	M	Issue No.	22
LM End	1.33	Issue Type +	Ma	Location *	WS
Category	Earthen Levee			GPS Latitude/Longitude	
				Start	End
Item	Erosion / Bank Caving			39.171218 °	39.171218 °
				-121.735258 °	-121.735258 °
DWR ID	DWR_ST0020_01_f_2016_22				
Comment Code					
E1 : Note and monitor erosion site.					
Inspector Comment

View of the erosion along the bank.

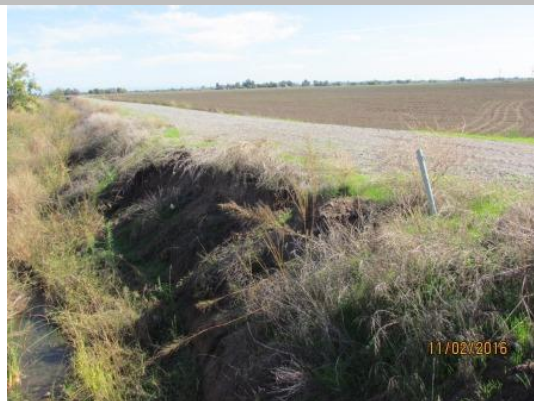
Photo 1 of 1 : FA_2019_ST0020_213_24_20190822_00010.jpg

LM Start	1.36	Rating **	M	Issue No.	24
LM End	1.36	Issue Type +	Ma	Location *	WS
Category	Earthen Levee			GPS Latitude/Longitude	
				Start	End
Item	Erosion / Bank Caving			39.171220 °	39.171220 °
				-121.734730 °	-121.734730 °
DWR ID	DWR_ST0020_01_f_2016_24				
Comment Code					
E1 : Note and monitor erosion site.					
Inspector Comment

View of the erosion along the bank.

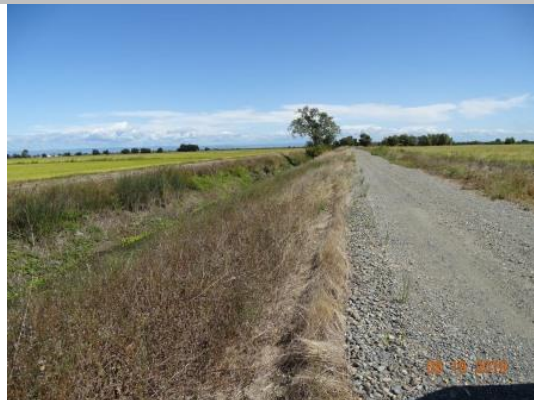
Photo 1 of 1 : FA_2019_ST0020_214_33_20190920_00081.jpg

LM Start	0.01	Rating **	M	Issue No.	33
LM End	0.26	Issue Type +	Ma	Location *	WS
Category	Earthen Levee			GPS Latitude/Longitude	
				Start	End
Item	Vegetation			39.171164 °	39.171025 °
				-121.726190 °	-121.721526 °
DWR ID	DWR_ST0020_02_f_2019_33				
Comment Code					
V1 : Control annual grass and weeds on the levee slopes and easements.					
Inspector Comment

View of the vegetation along the waterside slope. Fall 2019.

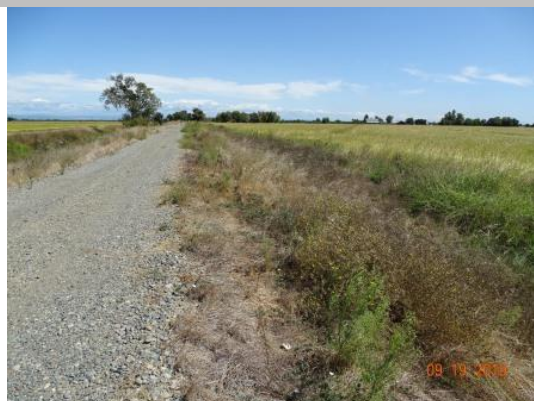
Photo 1 of 1 : FA_2019_ST0020_214_34_20190920_00082.jpg

LM Start	0.01	Rating **	M	Issue No.	34
LM End	0.26	Issue Type +	Ma	Location *	LS
Category	Earthen Levee			GPS Latitude/Longitude	
				Start	End
Item	Vegetation			39.171159 °	39.171024 °
				-121.726173 °	-121.721526 °
DWR ID	DWR_ST0020_02_f_2019_34				
Comment Code					
V1 : Control annual grass and weeds on the levee slopes and easements.					
Inspector Comment

View of the vegetation along the landside slope. Fall 2019.

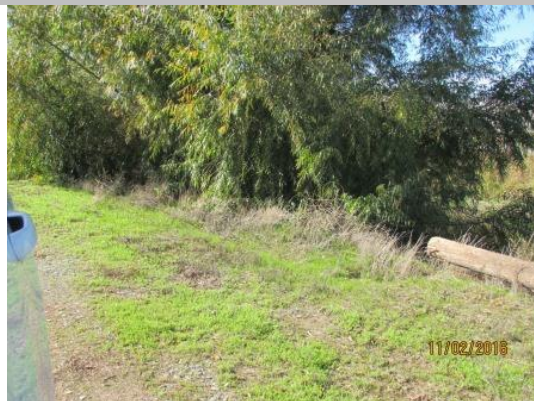
Photo 1 of 1 : FA_2019_ST0020_214_31_20190822_00009.jpg

LM Start	0.30	Rating **	M	Issue No.	31
LM End	0.30	Issue Type +	Ma	Location *	WS
Category	Earthen Levee			GPS Latitude/Longitude	
				Start	End
Item	Trim / Thin Trees			39.171061 °	39.171061 °
				-121.720853 °	-121.720853 °
DWR ID	DWR_ST0020_02_f_2016_31				
Comment Code					
T1 : Trim trees to at least five feet above ground level.					
Inspector Comment

View of the overgrown trees blocking visibility and access.

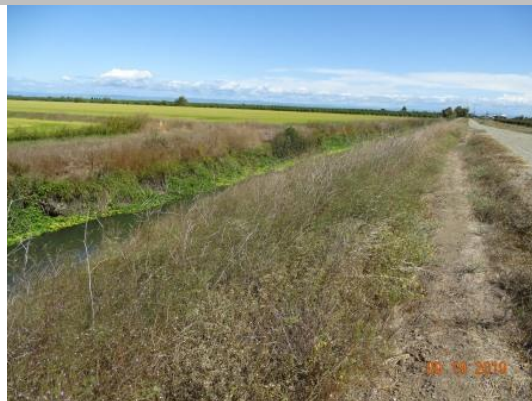
Photo 1 of 1 : FA_2019_ST0020_214_37_20190920_00083.jpg

LM Start	1.01	Rating **	M	Issue No.	37
LM End	1.31	Issue Type +	Ma	Location *	WS
Category	Earthen Levee			GPS Latitude/Longitude	
				Start	End
Item	Vegetation			39.170916 °	39.170826 °
				-121.707632 °	-121.701979 °
DWR ID	DWR_ST0020_02_f_2019_37				
Comment Code					
V1 : Control annual grass and weeds on the levee slopes and easements.					
Inspector Comment

View of the vegetation along the waterside slope. Fall 2019.
